# Hartest river corridor survey

<i><b>Project no.</b></i>	<i><b>Report</b></i>	<i><b>Date</b></i>
56/15	Final	21st September 2015
<i><b>Prepared by</b></i> Penny Hemphill BSc. Hons	<i><b>Checked by</b></i> Simone Bullion BSc. Hons, PhD., MCIEEM

## SWT Trading Ltd

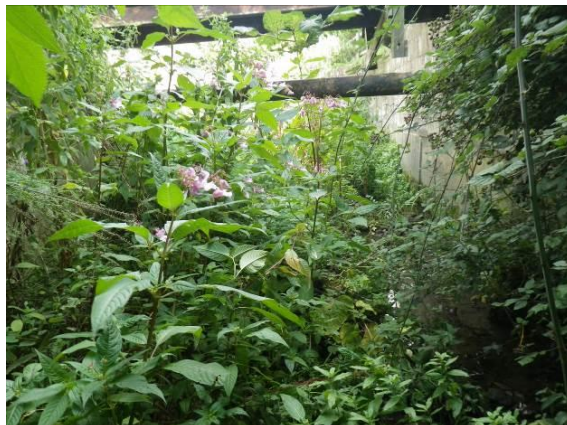
- Floristically the river is devoid of aquatic plants due to the shaded conditions and stone dominated channel. Willowherb, bramble and nettles occurred on the banks most frequently along with Himalayan balsam a non-native species which was recorded generally as single plants throughout the survey section. Ferns and liverworts thrive in the shaded conditions afforded by the bankside trees - ferns were recorded growing out of walls and liverworts covering stones and boulders in the northern section. There was a short stretch of more open water along the northern section where water parsnip dominated the channel.

Himalayan balsam

- Himalayan balsam is an invasive species which will eventually become the dominant plant along the river if not controlled. The seeds are dispersed by an explosive action when touched, so it is important to pull the plant when it is in flower and before it has set seed to avoid further dispersal of the seeds. Either the residents could be encouraged to pull the plant along their section of river, or Suffolk Wildlife Trust could assist through their 'Water for Wildlife' Project. Any work along this river could be hazardous due to the steep banks, so that must be taken into account before any work in the channel is attempted.

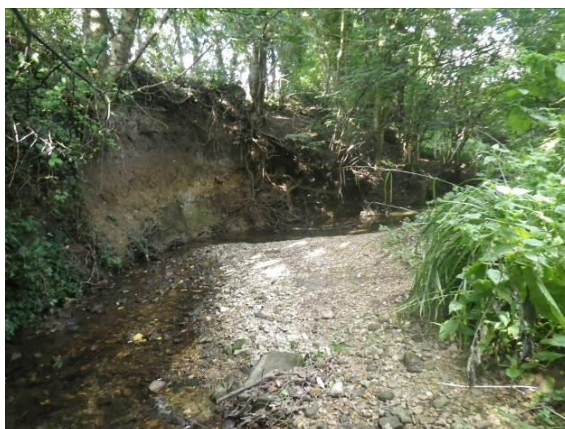
The river is a tributary of the River Glem, part of the Stour river catchment which is the county boundary between Suffolk and Essex. This is a reactive water-course which will take water from the surrounding arable ditches and as a result will have fluctuating water levels and is likely to be virtually dry in summer months. The stretch of river included in the survey is from north-west of the road bridge at TL 83290 52700 to the southern end of the village at TL 83246 51832. The river has steep banks up to four metres in height in places which are sometimes vertical with earth cliffs and bankside tree roots scoured out by high winter water levels.

Earth cliff & tree roots scoured out by high flow

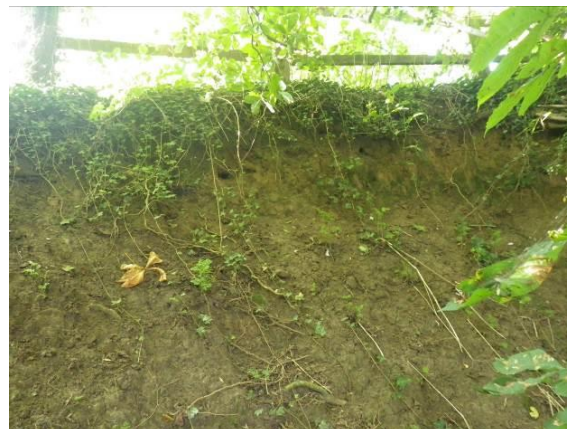
- Fish fry were seen along the channel and it is likely that bullhead is present under the stones in the river bed where water levels allow.
- Kingfisher burrows were recorded high up on a sand cliff along the left bank in the southern section.

Kingfisher burrows in top of cliff

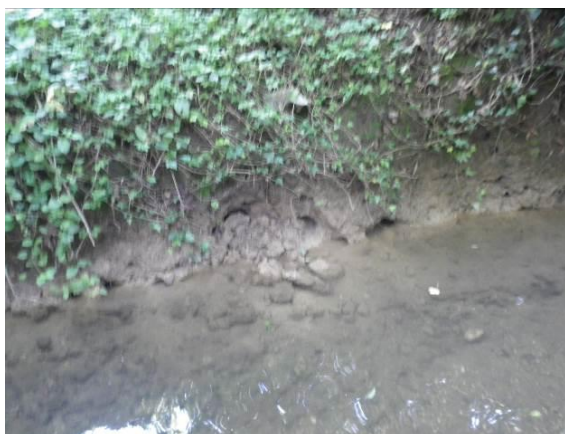
Signal crayfish burrows

- The current impact from signal crayfish on the channel is minimal however they will affect the invertebrate and fish populations of the river and can cause bank erosion through burrowing. If residents wish to remove them from the river it is necessary to apply for a trapping licence from the Environment Agency to do so. Co-ordinated trapping is not recommended, as this results in the removal of the largest crayfish and this has been shown to have an adverse effect on fish and aquatic invertebrate populations. This is because the

larger crayfish prey on the smaller crayfish and to some extent this reduces the impact on this non-native species.

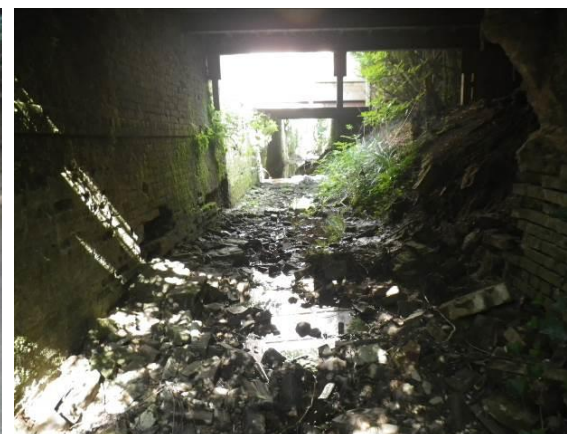
- Otter activity was recorded along the northern stretch. Footprints in soft mud on the left bank and a spraint was located on a boulder under a bridge. The spraint was full of signal crayfish shell.
- Scrub habitat and occasional mature trees provide potential otter holt sites along the southern section particularly on the left bank where there are no gardens but a belt of trees and scrub between the river and adjacent arable land.
- Signal crayfish burrows recorded on the southern section of the river low down along the bank at water level. The river bed is ideal for this species which live under stones and

boulders and it is known that the River Glem has a high population of this non-native species.

Stones and boulders on river bed suitable for crayfish

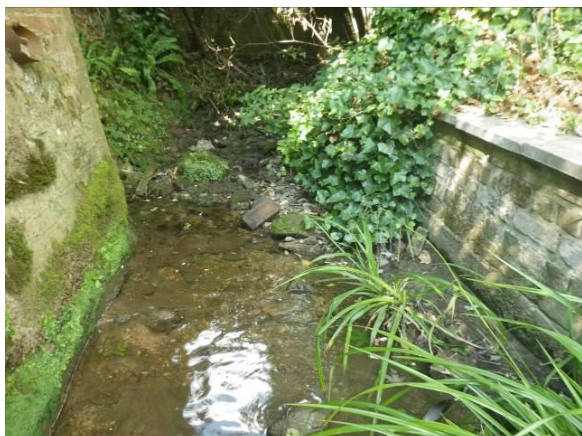
Otter footprints recorded on muddy ledge right bank

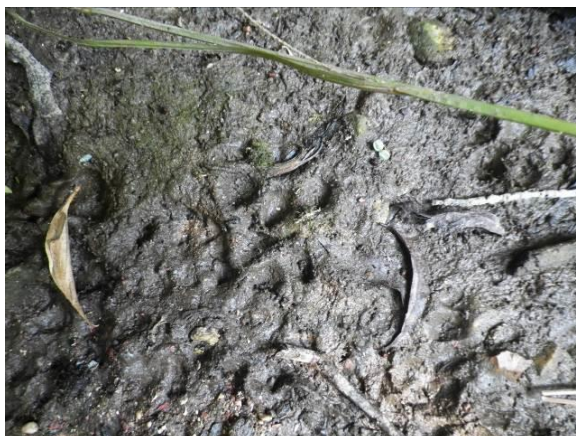
Otter footprints

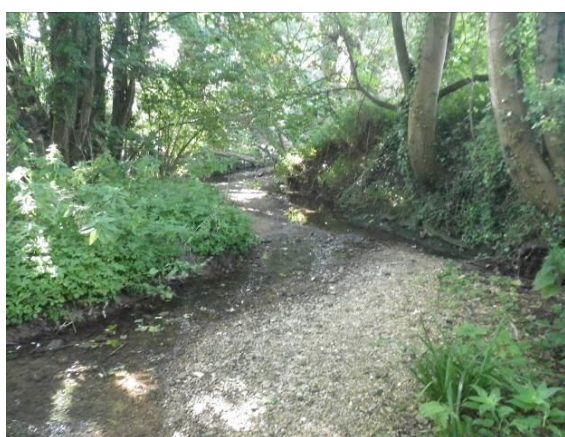
Good otter habitat on both banks southern section

- The tree and scrub habitat on the left bank along the southern section is ideal habitat for otter and there are occasional mature trees which are suitable holts sites for the animals. This habitat should remain undisturbed.

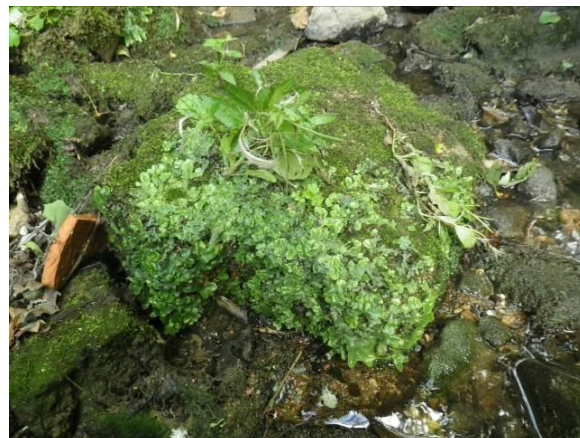
Liverworts covering boulder

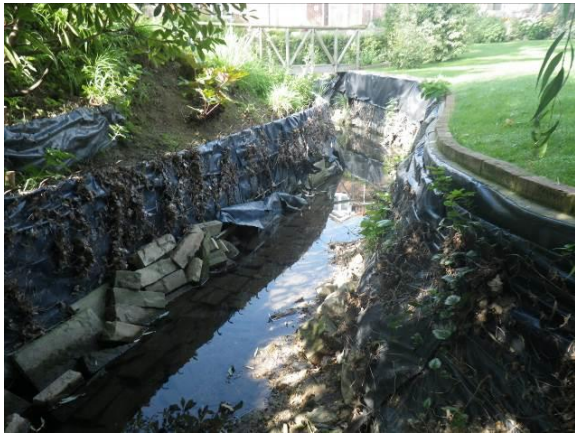
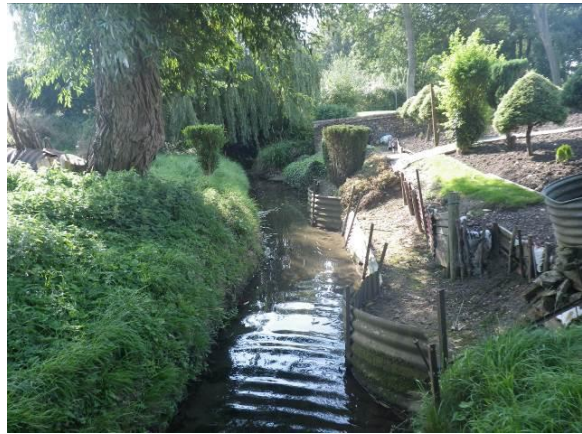
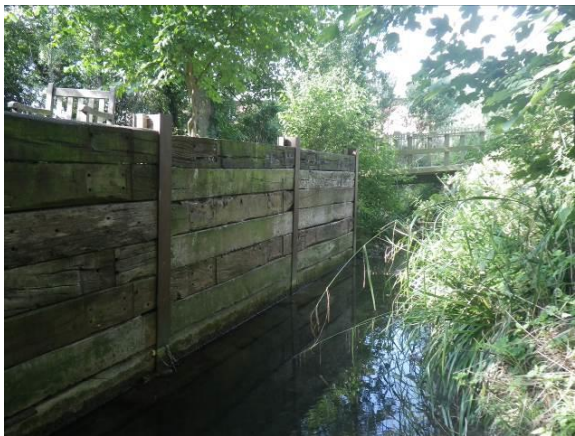
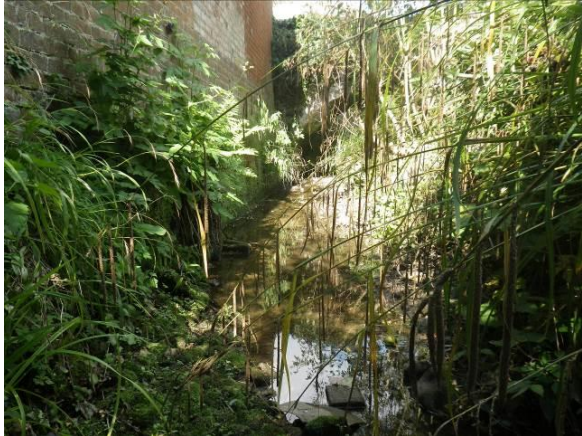
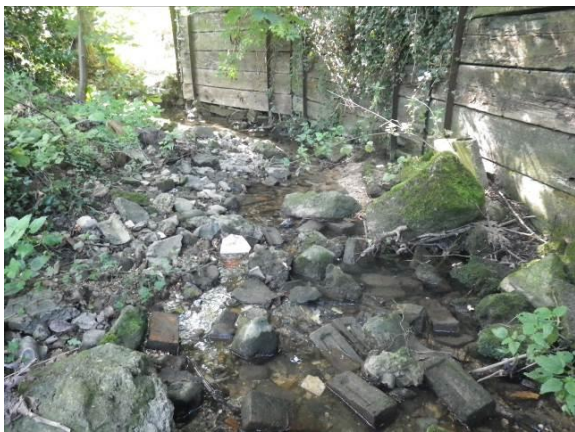
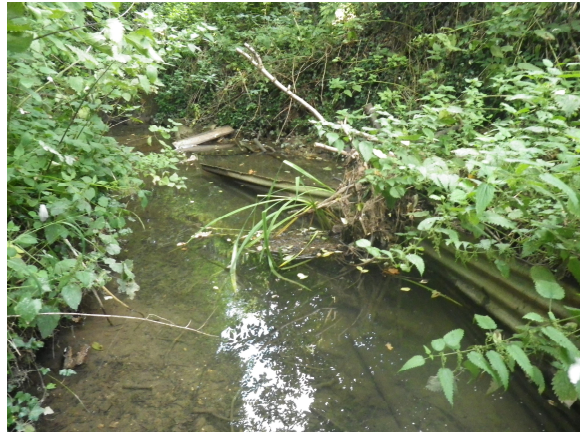
The northern section of the water-course flows behind buildings and through gardens. Most of the banks along this section are either walls or have been reinforced so there is little natural habitat. Trees are frequent along the banks which shade the channel and the river bed is stones, boulders and gravel with sand and occasional silt. As a result there is no aquatic vegetation.

- The various methods of reinforcing the river banks are inventive and effective, however in some instances have reduced the ecological value of the channel.

Various methods of bank reinforcement along the channel
